ANNUAL REPORT FOR 2002

**White Oak Creek
Johnston County
Project No. 6.408014T
TIP No. R-2000 WM**

Prepared By:
Office of Natural Environment & Roadside Environmental Unit
North Carolina Department of Transportation
December 2002/ Revised March 2003

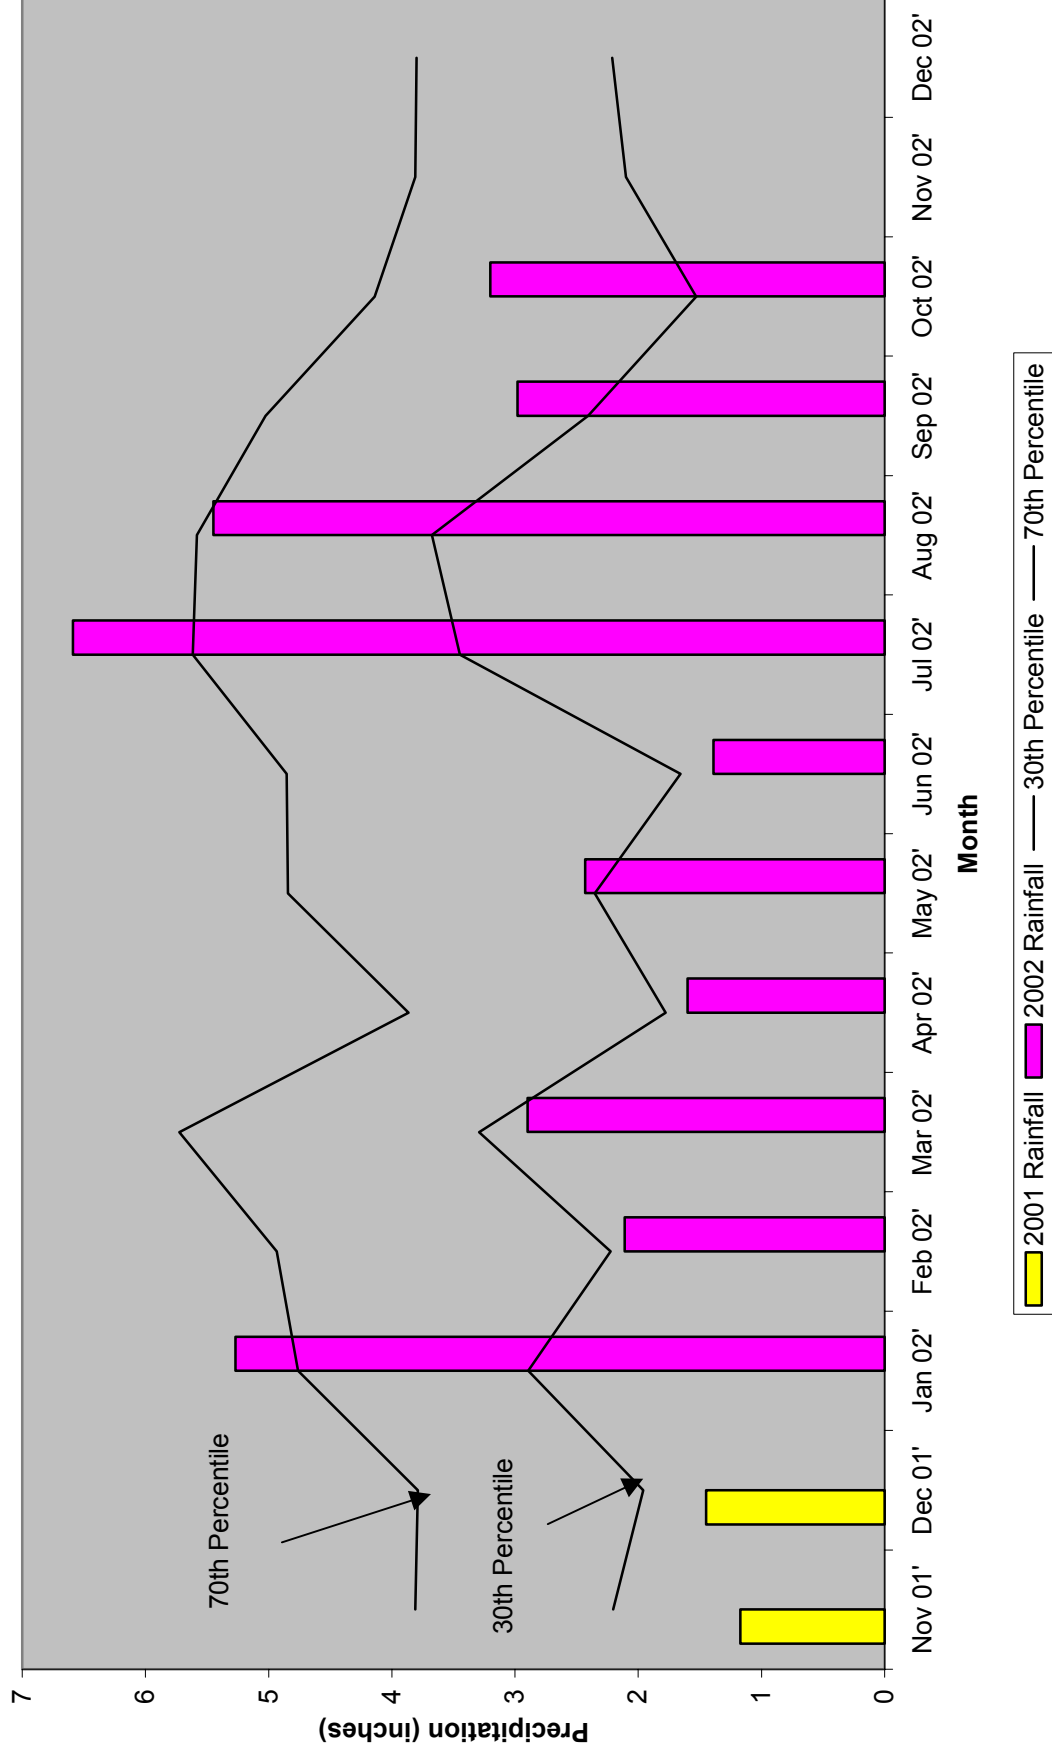
Figure 4
White Oak Creek 30-70 Percentile Graph 2002
Clayton, NC

Figure 4 represents an examination of the local climate in comparison with historical data in order to determine whether 2002 was “average” in terms of rainfall. The two lines represent the 30th and 70th percentiles of monthly precipitation for Clayton. The bars are the monthly rainfall totals for parts of 2001 and 2002. The historical data and monthly rainfall was collected by the National Climatic Data Center. Months with below average rainfall include November (01’), December (01’) February, March, April, and June. The months of May, August, September, and October all recorded average rainfall for the site. January and July recorded above average rainfall. Overall the site experienced below average rainfall in 2002.
